International Fire
Conference &
Exhibition Malaysia

SUSTAINABLE FIRE SAFETY TAKING FIRE SAFETY IN CAR PARKS TO A NEW LEVEL

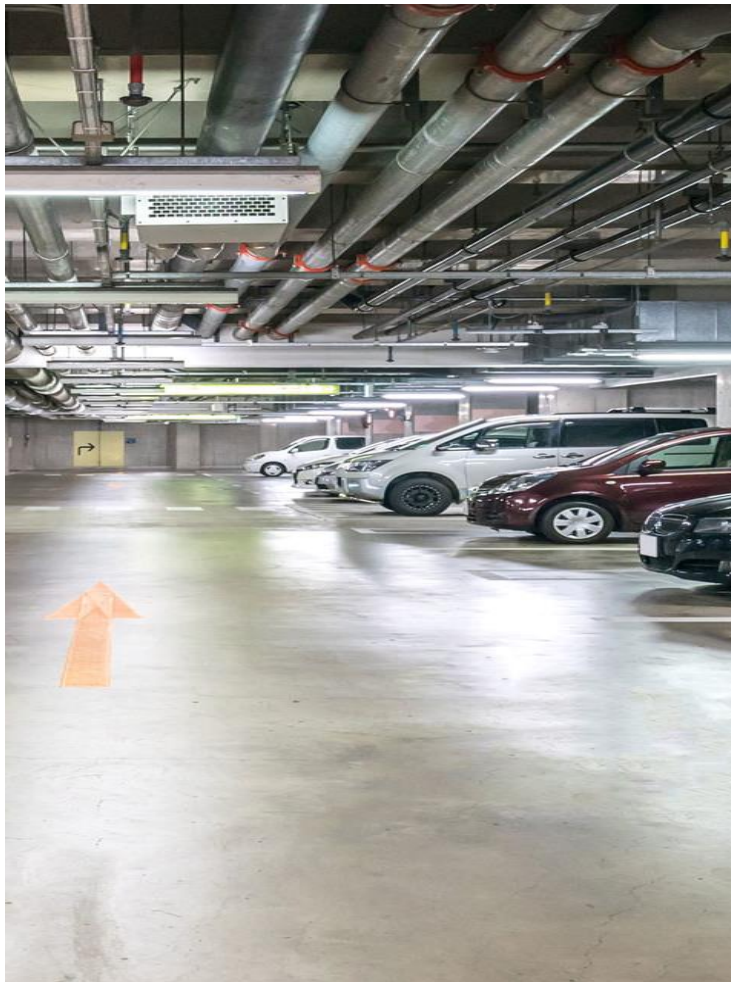
- Stand-alone construction or attached to other occupancies
- Car stacking mechanisms, where hydraulic systems lift two or more cars above each other, effectively inside the footprint of a single car

Relatively large, open spaces, little in the way of internal separations. Generally, the floor-to-ceiling height is less than other building types and can be as low as 7.22 feet (2.2 meters). The structural capacity of the garage must be sufficient to support its own weight plus the weight of the vehicles, etc. The design needs to consider factors such as the movement of vehicles to and from the parking bays, the size of the bays to accommodate the vehicles, plus space to allow passengers with different physical capabilities to exit and enter the vehicles

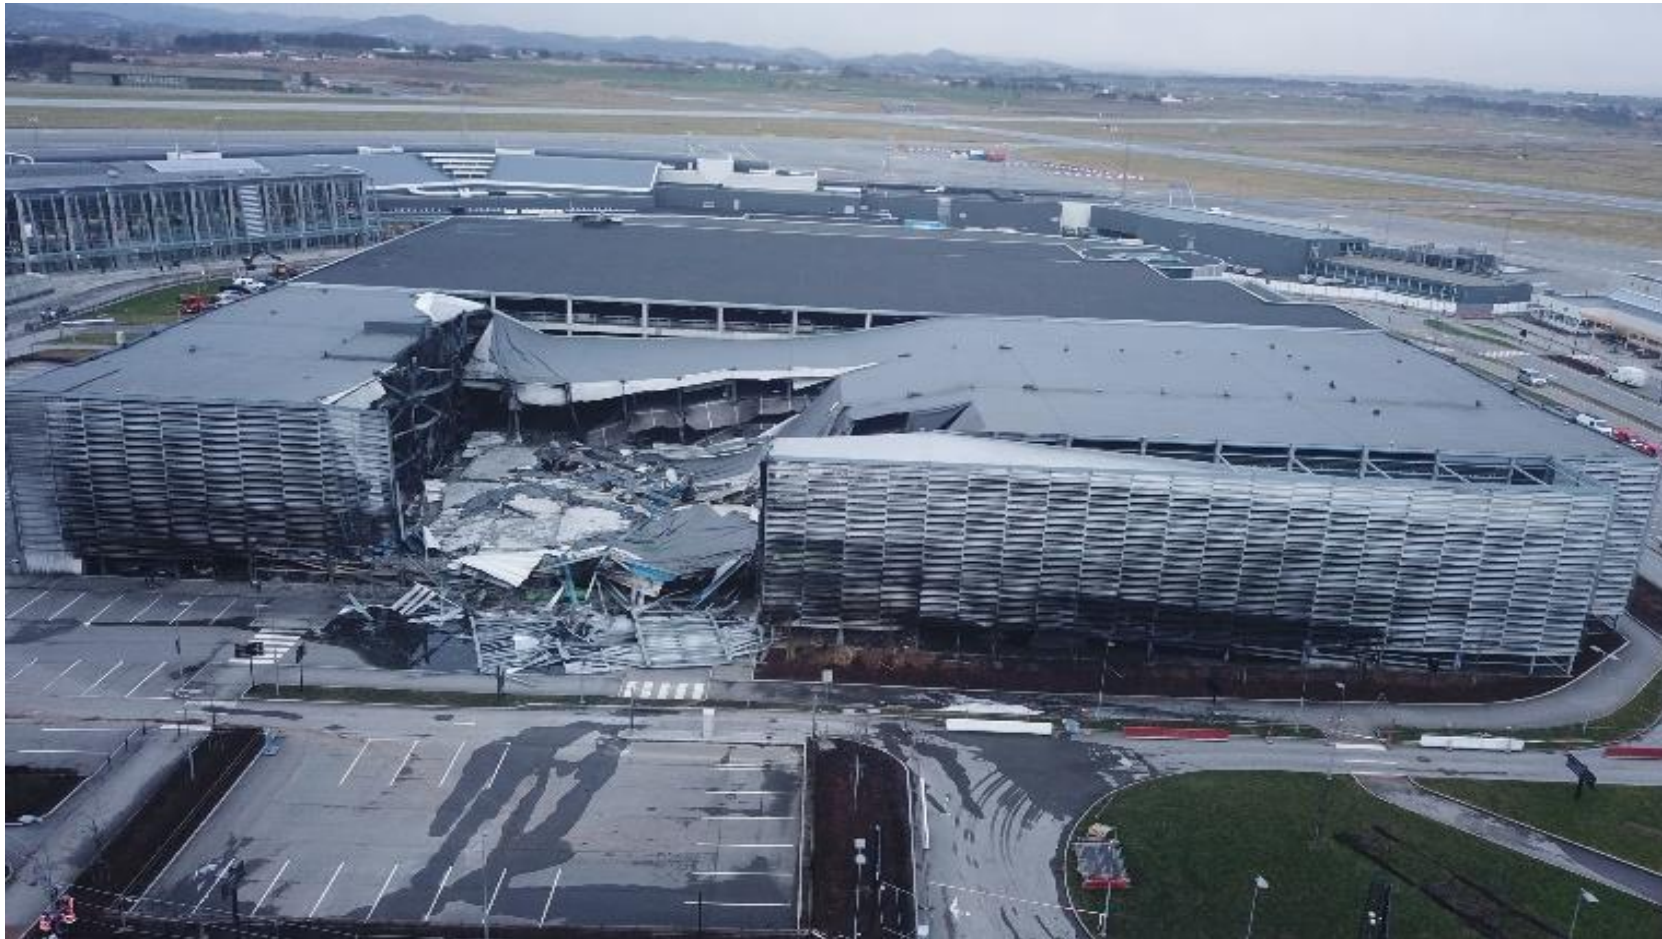
CASE STUDY (LESSONS LEARNED)

- The incident investigation reported that the fire spread rapidly to several vehicles, aided by both strong winds (around 11-12 m/s with 19 m/s gusts) and the leakage of fuel from burning vehicles.

- The carpark consists of three distinct parts, each using different construction methods and opened in 1991, 2001 and 2014 respectively. The fire broke out in a diesel vehicle on the ground floor of the central portion of the building (constructed in 2001), which was a concrete structure using elements with a fire resistance level (FRL) of 60 minutes.

- The newest portion of the carpark was constructed from steel primary structure and a composite (steel and concrete) deck. The fire strategy specified 15 mins of load-bearing capacity for the columns and 10 mins for the beams, citing the BHP Steel research (discussed in Section 4.3) as evidence of suitability. After around two hours, parts of the 2014 building down-wind of the fire origin location collapsed.

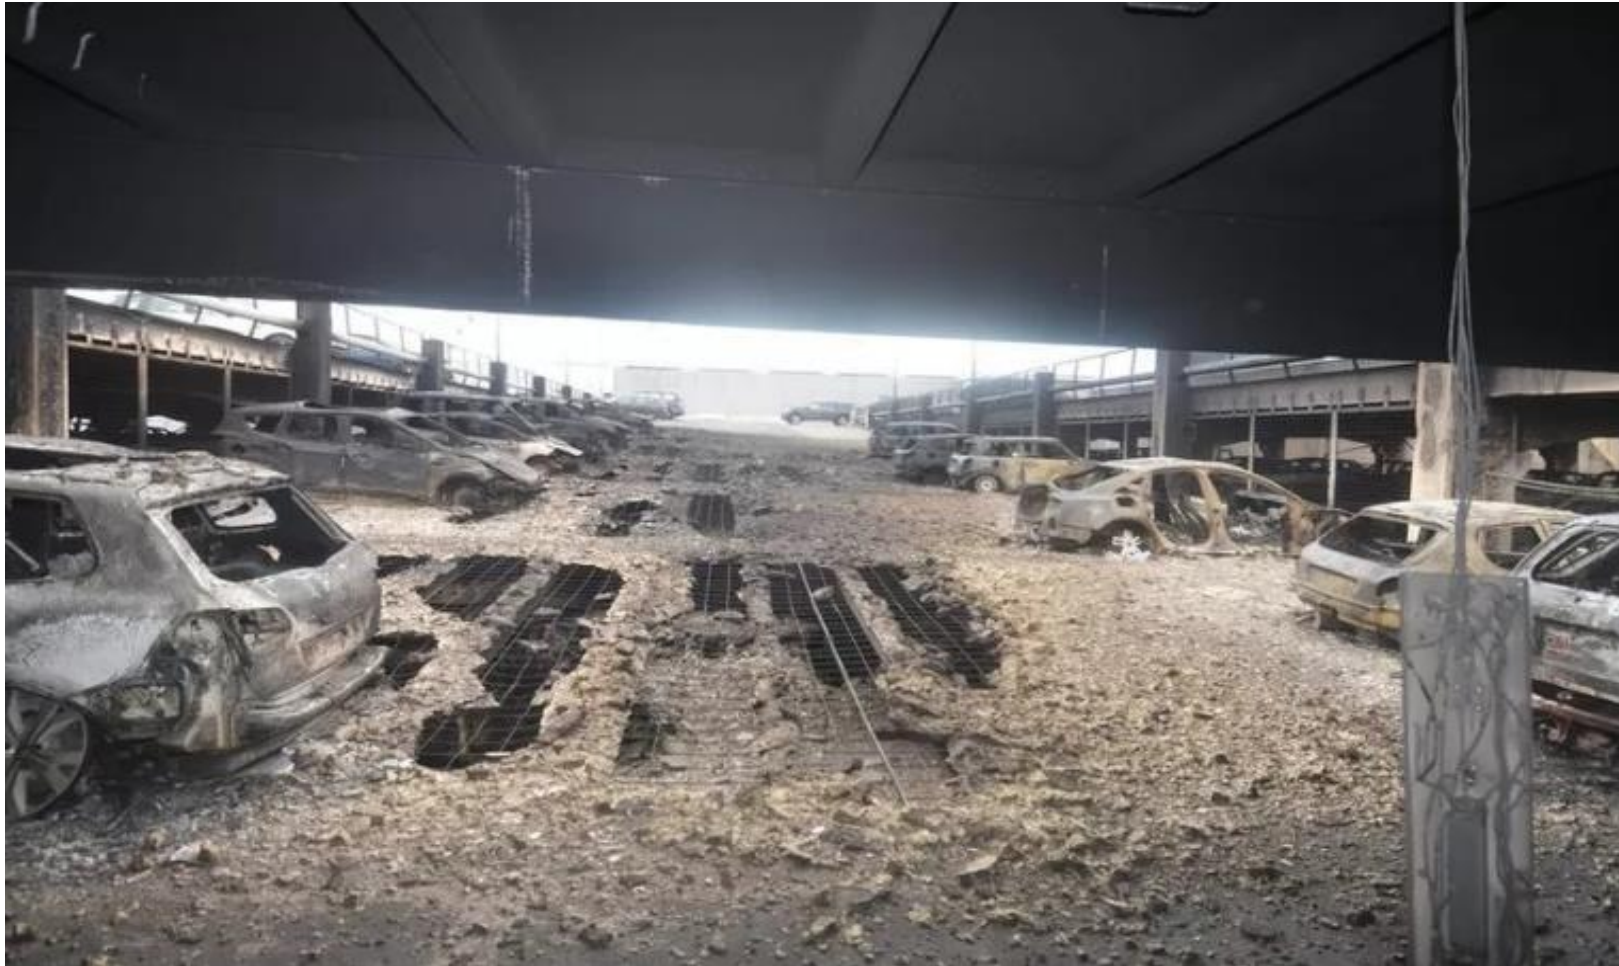
CASE STUDY 2

- The carpark measured approximately 77 m x 64 m (using a floorplan reproduced in the MF&RS's report) [63], and had eight storeys (G+7). It complied with local building regulations for open-sided carparks. On the afternoon of the fire (on New Year's Eve) an event was being held at the arena, therefore many vehicles were present in the carpark. The fire originated on Level 3.
- It is thought that the high patronage contributed to the quick spread of the fire from one vehicle to another. Additionally, it took a relatively long time for the alarm to be raised. The first emergency call was 13 minutes after the first signs of fire. Some of the first occupants to witness the fire did not raise the alarm

- The building had a 15-minute FRL. Remarkably, the concrete structure remained standing after the fire, even though there were clear signs of explosive spalling, floor failure and structural element damage .
- Suggesting that fire safety guidance should be revisited, particularly where there is a carpark beneath a block of flats or offices or a timber-framed building. The MF&RS protection report stated that the fire could have been contained if a sprinkler system had been installed

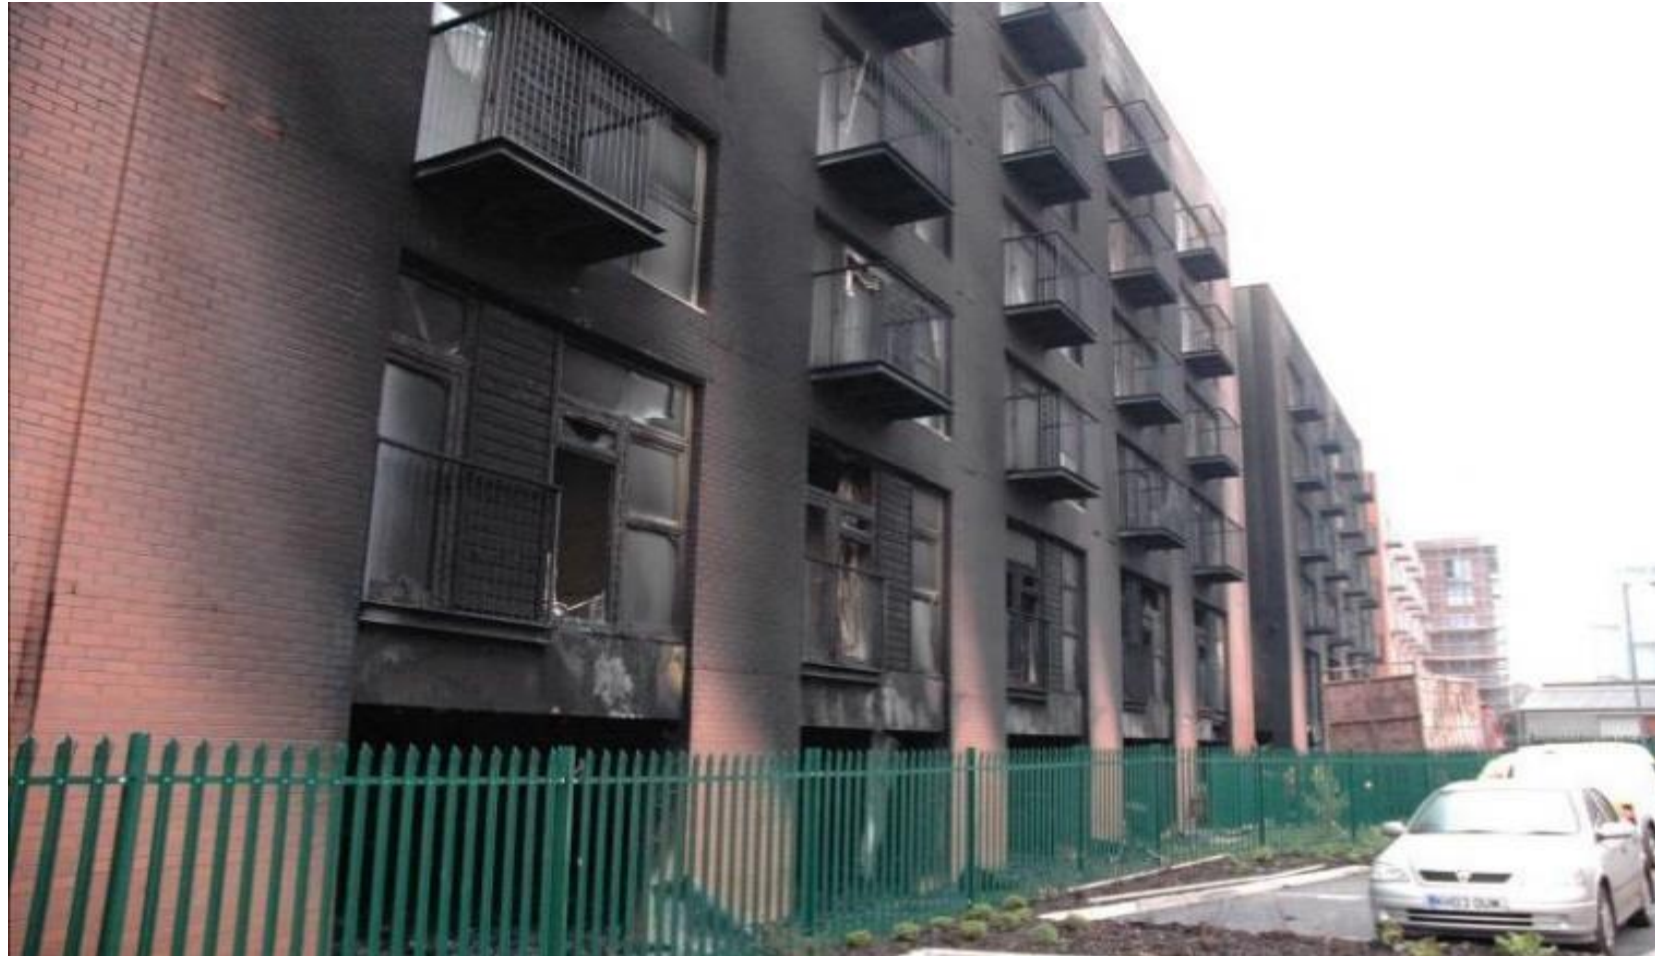
CASE STUDY 3

- The fire occurred in the underground carpark of a newly constructed residential care home. The construction complied with the Building Regulations; the care home was sprinklered, but the carpark was not. The fire destroyed 22 cars and subsequently spread to the upper residential levels through external windows. One fatality was caused by smoke inhalation and 60 residents had to be evacuated. It is believed that the residential sprinkler system delayed the fire spread into the residential area . Extensive spalling of the carpark concrete was observed.

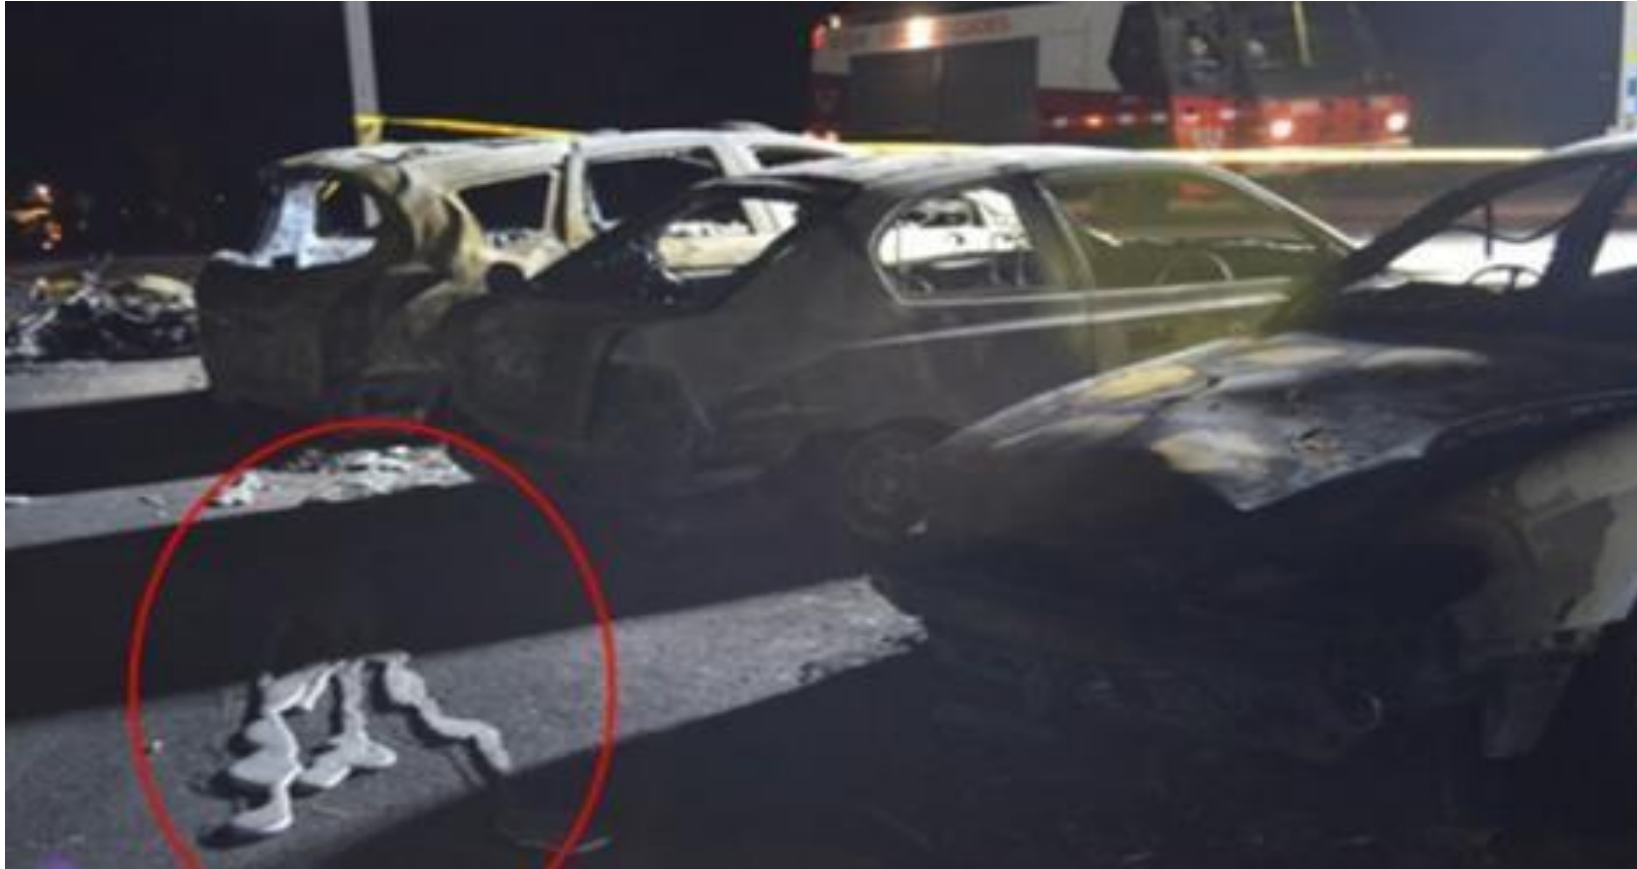
CASE STUDY 4

- The fire initiated in a garden, ignited by a cigarette butt. Several factors contributed to the fast fire spread in this incident, despite being an external parking area. Contributing factors included elevated ambient temperature, strong winds, a higher-than-normal carpark occupancy due to high patronage of the site, small separation between parked cars, as well as the presence of large quantities of mulch and vegetation in the surroundings, and high bushfire activity in the surrounding area, which limited the fire brigade response capacity. The control of the fire was hindered because of the restriction to not use foam as an extinguishing agent, considering the environmental damage to surrounding wetlands.

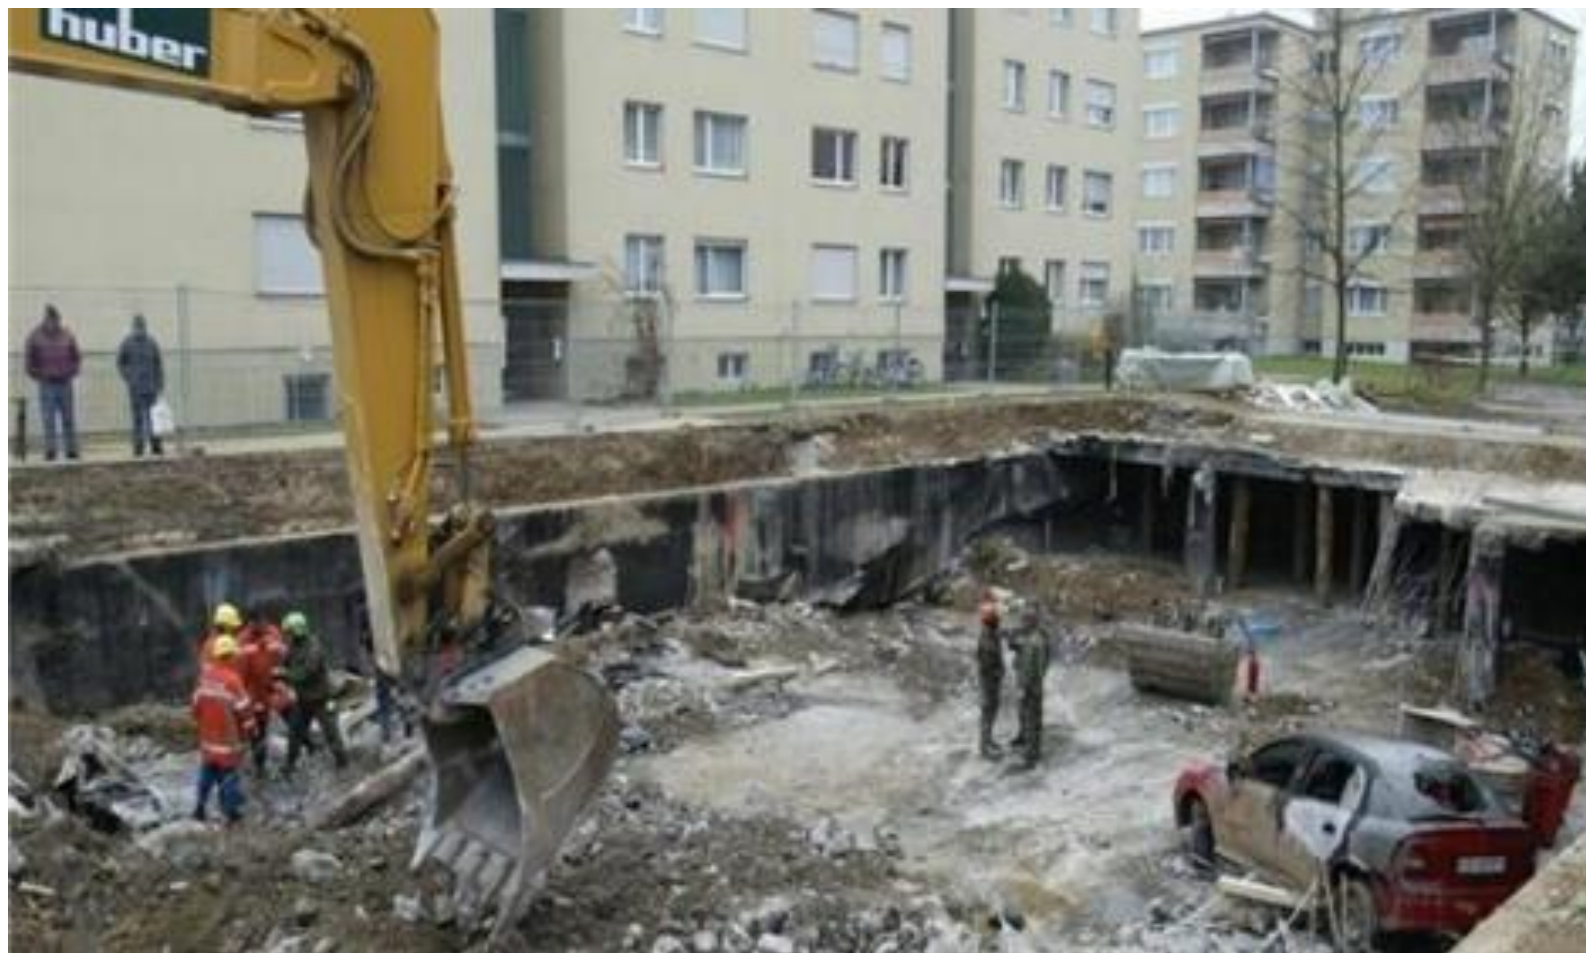
Fire investigation revealed there were errors in the structural calculations for the structure and on the construction resulting in an overload of soil and a decreased punching shear capacity, which caused the roof to collapse. 10 firefighters were trapped. Three were rescued, but seven died. Smoke spread to the stairs leading out of the building on top of the carpark. A technical defect in a parked car was thought to have initiated the fire.

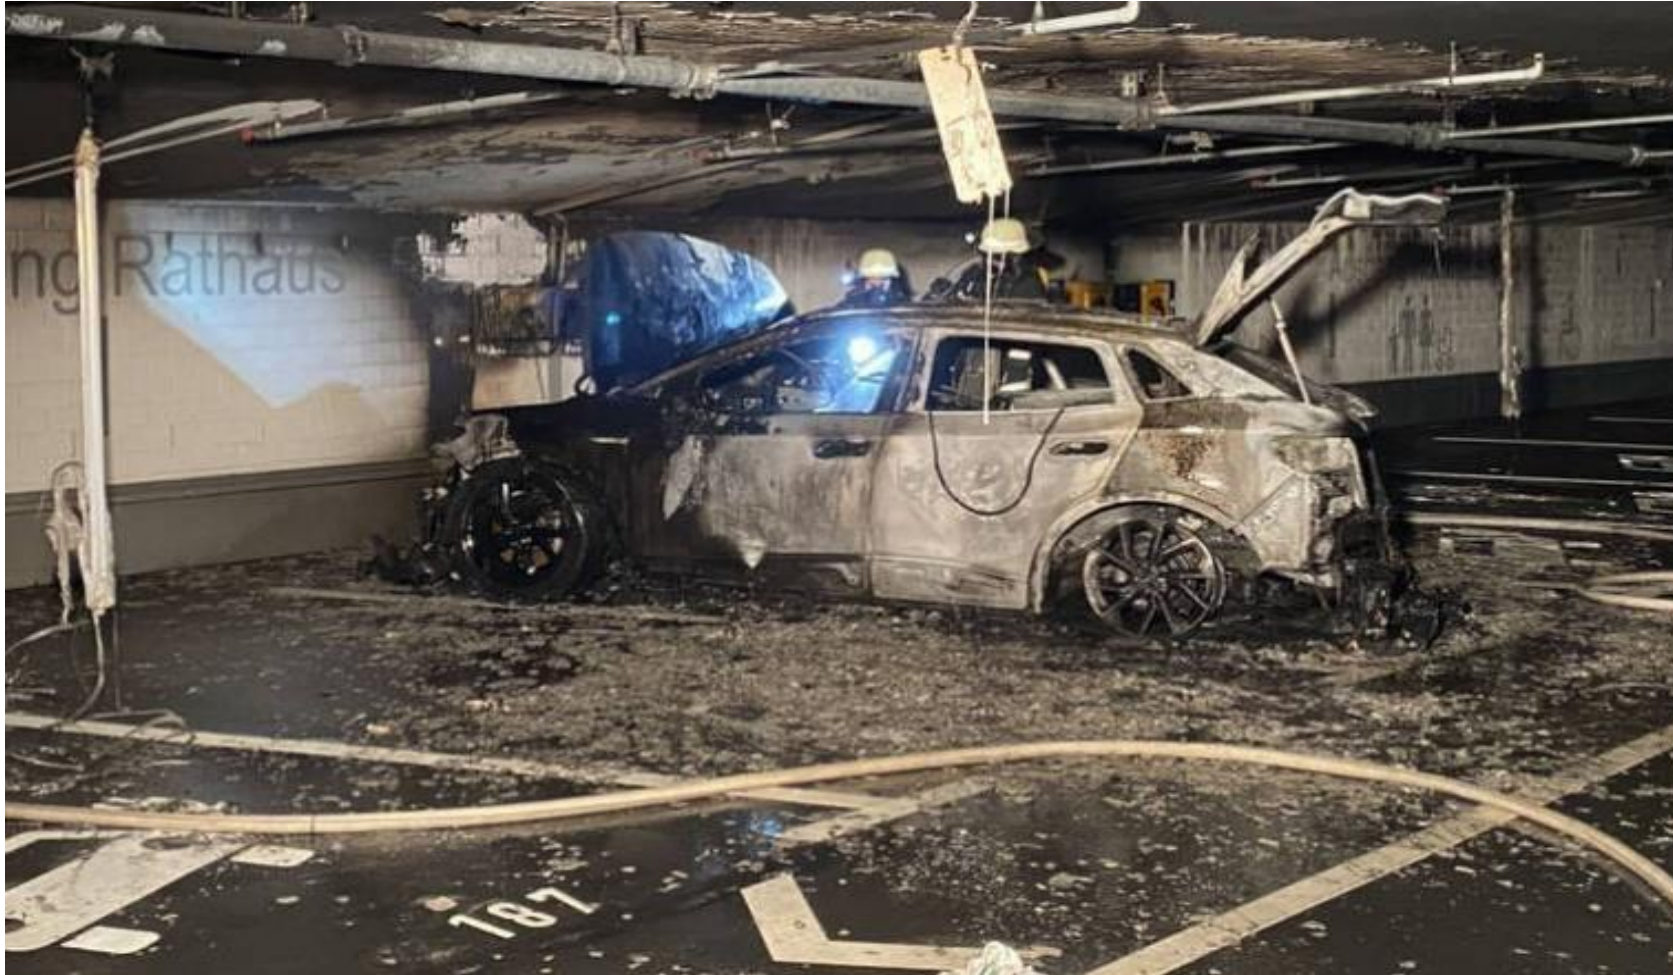
Case Study 5

- A fire started within an electric vehicle (EV) when it was charging in an underground carpark. The carpark was relatively new. The fire broke out in the middle of the night and the entire EV became involved, including the batteries [73]. “The position of the e-parking spaces apparently prevented worse things from happening”.
- The carpark was provided with a suppression system; sprinklers designed to Ordinary Hazard 2 (OH2) criteria as per European standards (with an application density of 5 mm/min over an area of operation of 144 m²). Whilst temperatures above the fire were high enough to cause minor spalling, the suppression system was effective at controlling the fire until the fire brigade arrived.
